Solar Alpha Rotary Joint Anomaly: The Materials & Processes Perspective

Aging Aircraft 2009

May 5th, 2009

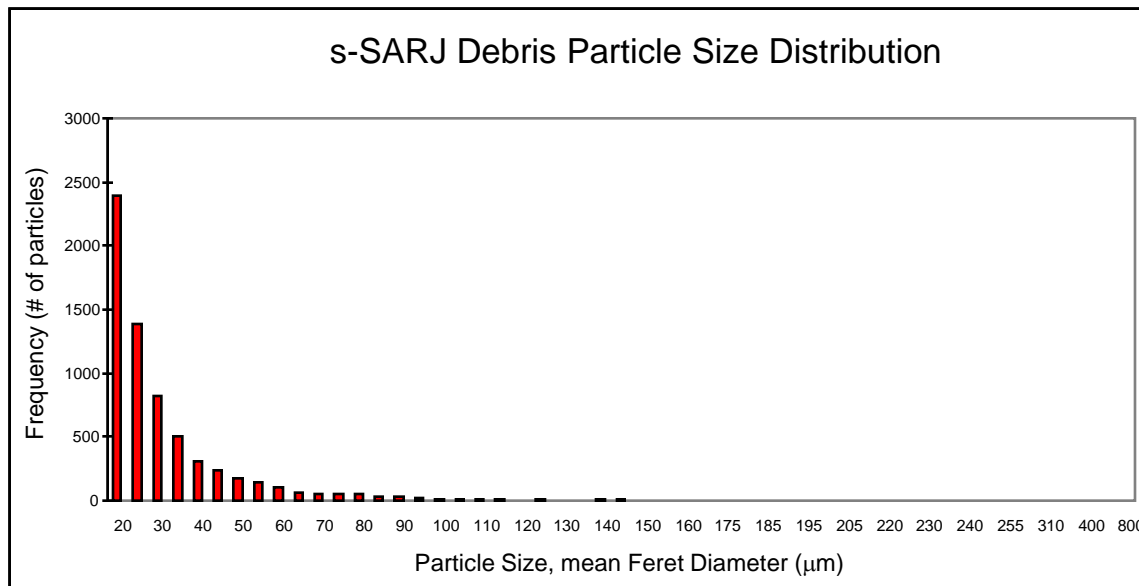
- Majority of debris is nitrated 15-5 PH Steel
 - Some gold, fluorinated grease, trace contaminants
- Only source of nitrated 15-5 PH steel is the race ring
- Particle size distribution skewed to fine particle size (less than 50 μm)

Image analysis particle size distribution

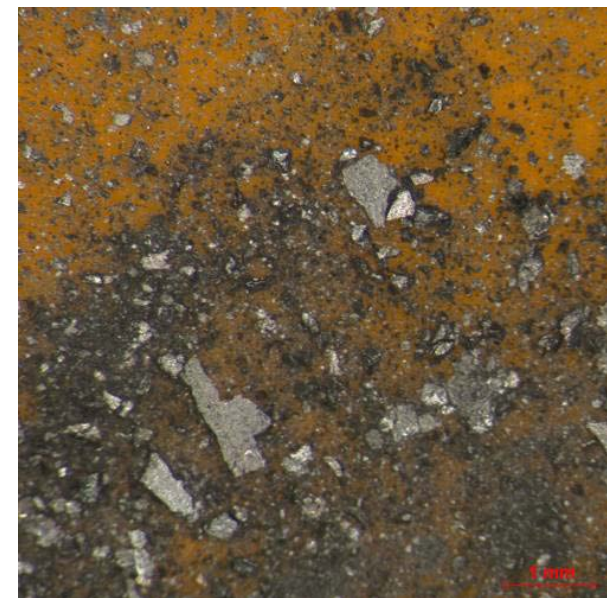
Stereomicroscope image.
Reference magnification: 20X

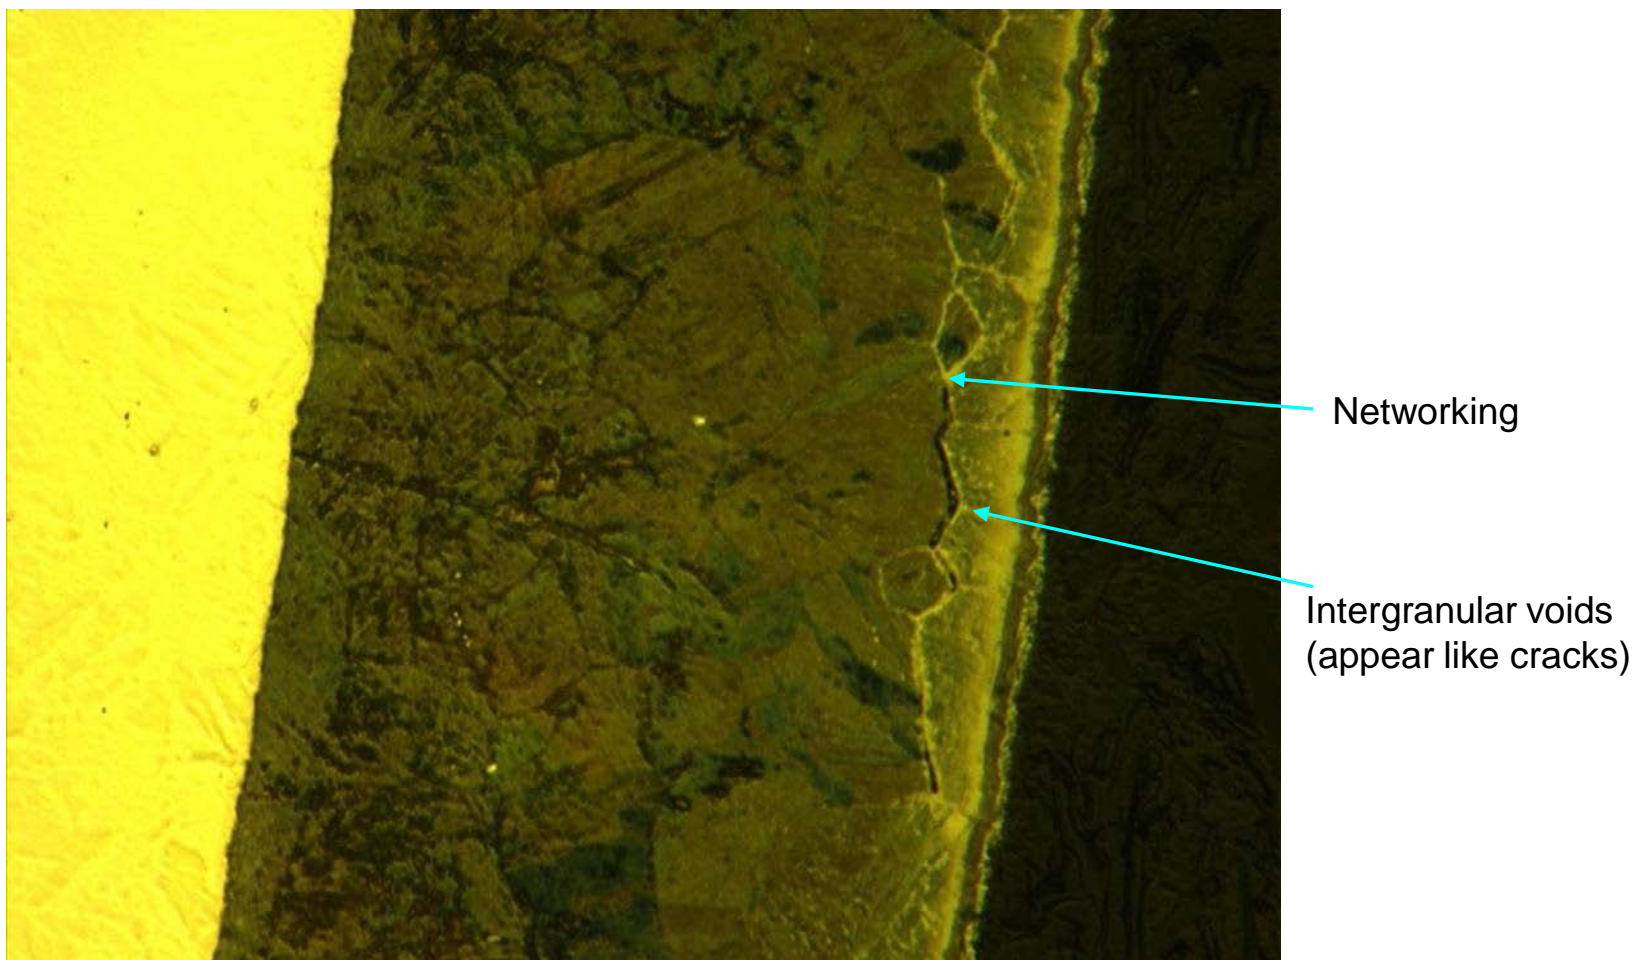
Nitride Control Coupon

- Metallographic examination determined white structure in excess of engineering requirements (0.0003in) is still present on the nitride control coupons (NCCs), maskant interface coupons (MICs), and on chip-type particles from the s-SARJ.
- While original certifications indicated that the white layer requirement was met, it appears that the specimen preparation technique was not sufficient to observe the true depth of inter-granular networking
- The inter-granular network (0.001 to 0.002in observed) appears as a higher concentration of iron and chromium nitrides along the grain boundaries
- Inter-granular separations or voids were also noted along some grain boundaries.

**Metallurgical Evaluation of SARJ Race Ring S/N 4
Sample Coupon (Polished, Etched and View @1000X)**

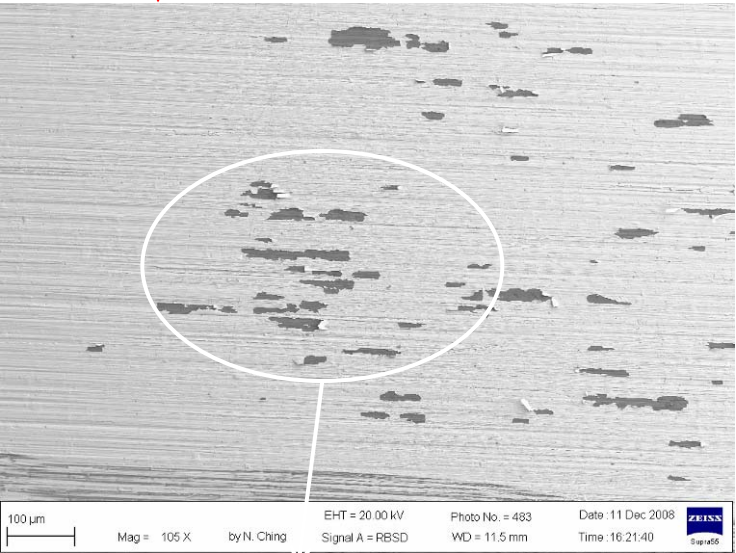
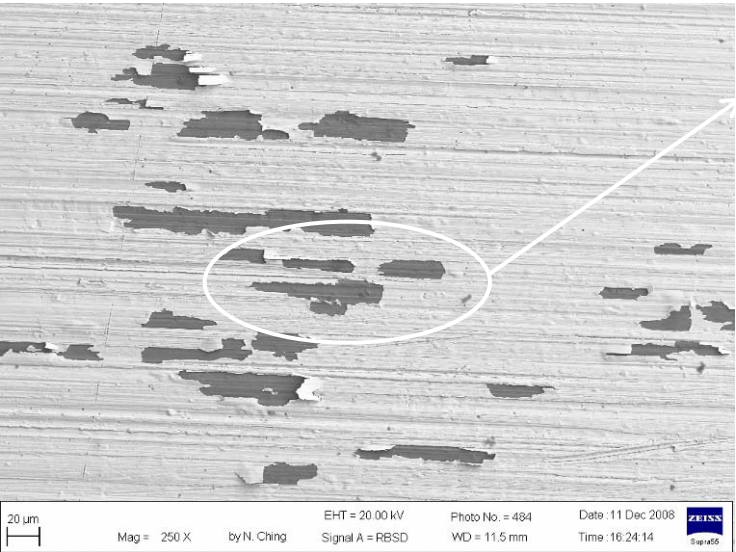
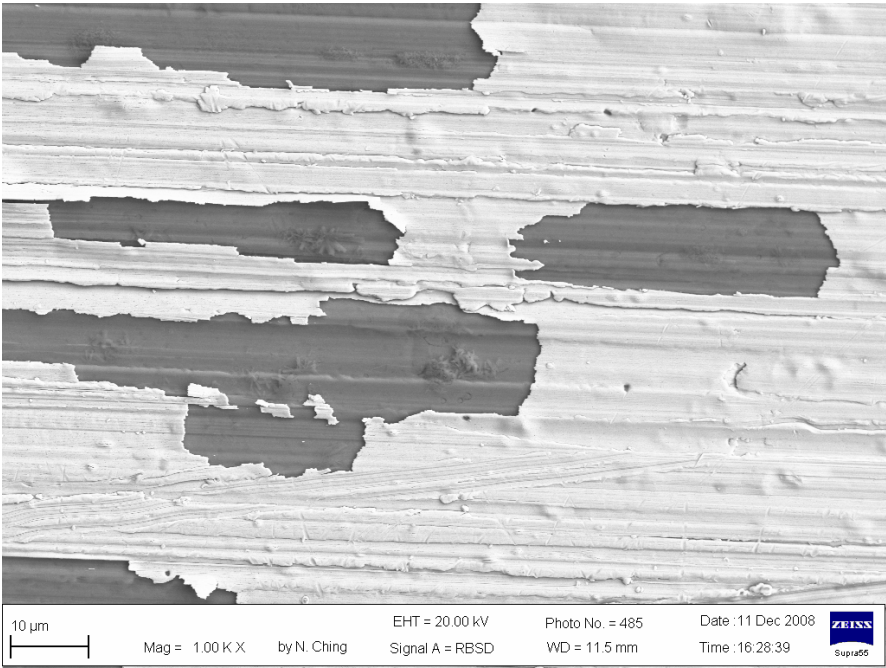
Accelerated Aging Test

- **Samples were then artificially aged, using high temperature and humidity**
 - **95F & 95%humidity for seven days – no changes were observed**
 - **Samples were returned to aging environment at a higher temperature (125F) for seven additional days – highly localized gold adhesion loss was observed**

- **Comparable area of iron oxide corrosion observed, undercutting adhesion between gold coating and substrate**
